# Manhole Inspection Summary

Manhole # S41AA\_076MH

**Inspection** ☐ Is Incomplete Rating: **5) Immediate Attention Required**

**Location** Address: **716 n eden st**

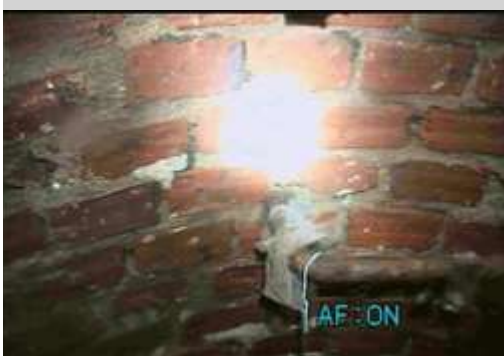
Defect 7

**Surcharge** ☒ **Evidence Of Surcharge** Depth: **6.4** (ft.) ☐ Active Surcharge Present

evidence of surcharge

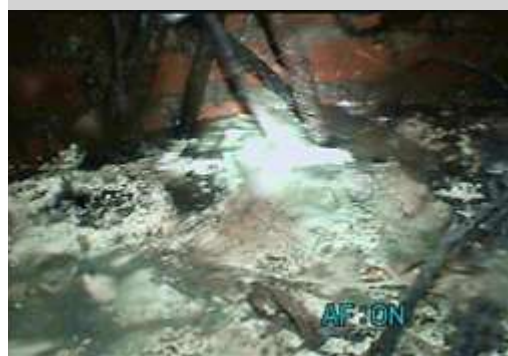
Defect 6

Condition: ☐ Sound ☐ Cracked ☐ Root Intrusion ☐ Deteriorated ☐ Leaks ☒ **Debris**

bench debris

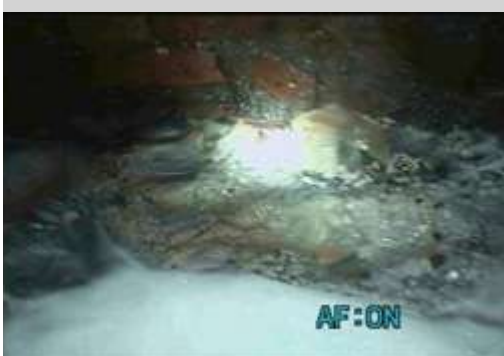
Defect 5

Condition: ☐ Sound ☐ Cracked ☐ Root Intrusion ☐ Deteriorated ☐ Leaks ☒ **Debris**

channel debris

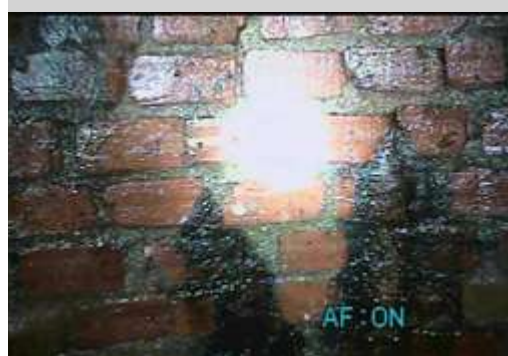
Defect 4

Infiltration: ☐ None ☐ Joint ☐ Cracks ☒ **Mortar** ☐ Roots ☒ **Wall**

infiltration in barrel mortar & wall

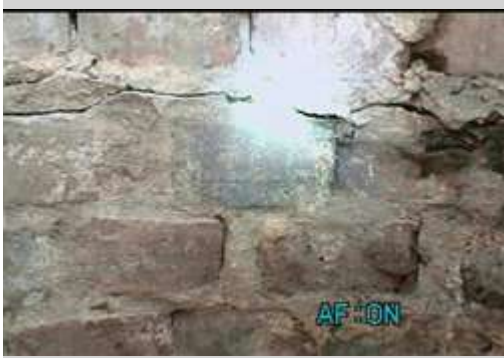
Defect 3

Condition: ☐ Sound ☒ **Cracked** ☐ Root Intrusion ☐ Loose Brick ☐ Deteriorated

cracked corbel

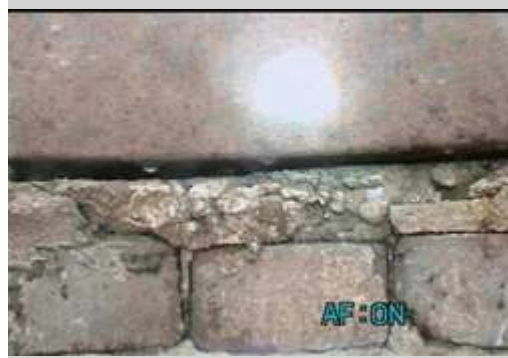
Defect 2

Condition: ☐ Sound ☐ Cracked ☐ Root Intrusion ☒ **Loose Brick** ☒ **Deteriorated**

loose bricks, deteriorating, frame adj

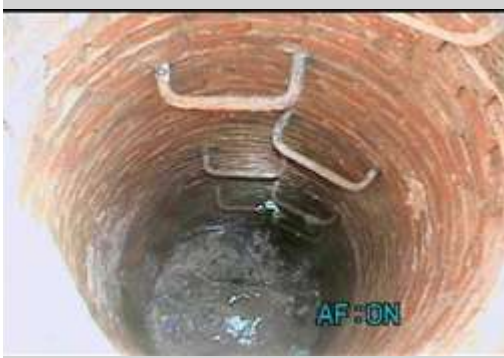
Defect 1

**Steps** Count: **9** Missing: **0** ☒ **Corroded**

steps

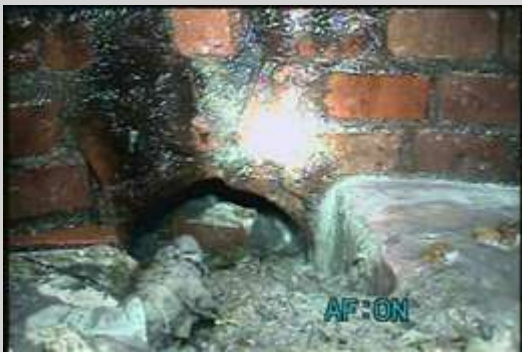
12 O'Clock Outflow

Invert Depth: 14.41 (ft.) Flow Characteristics: **Slow**

Deposits: ☐ None ☐ Mud ☐ Sludge ☒ **Debris** ☐ Grease

Silt Depth: 5 (in.) Deposits Extent: **Medium**
